Crash-test results and analysis of the impact of a non-professional repair on the performance of the side structure of a car (VW Passat)

KTI GmbH & Co. KG, Waldauer Weg 90a, D-34253 Lohfelden, GERMANY

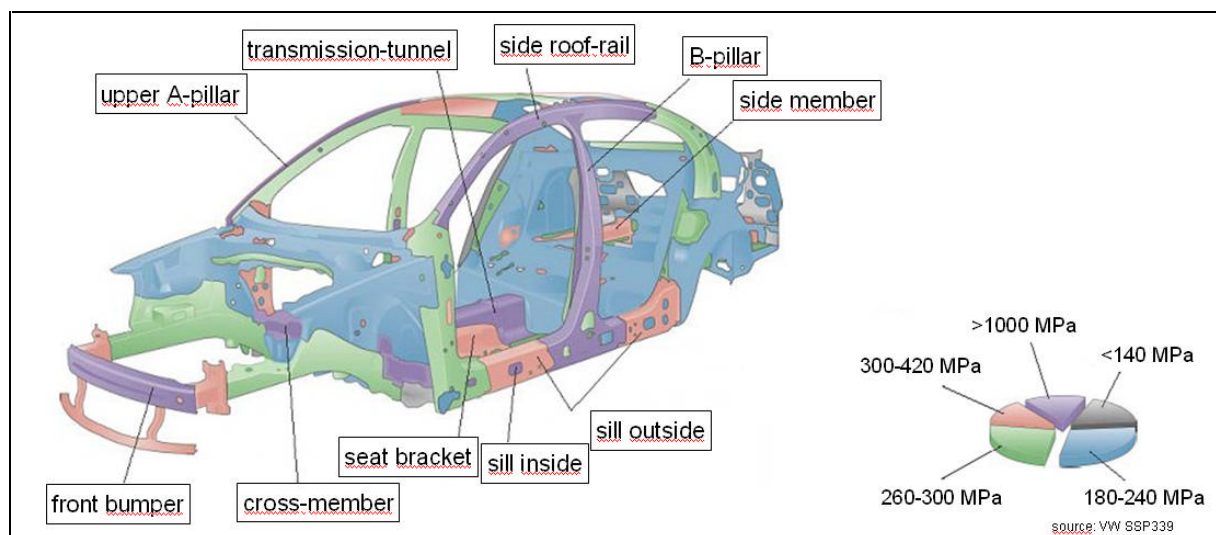
Figure 1. Distribution of steel grades in a VW Passat B6 (Source - VW)

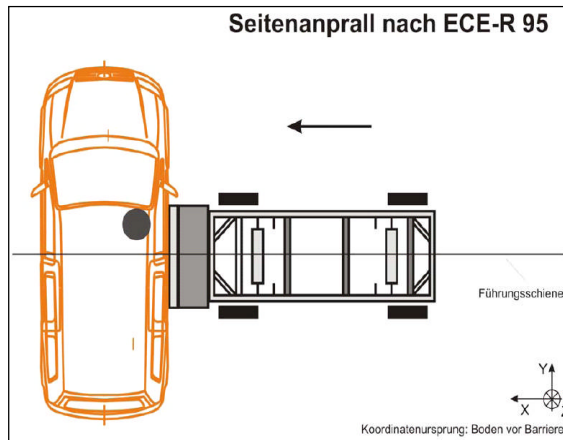
Figure 2. Test setup

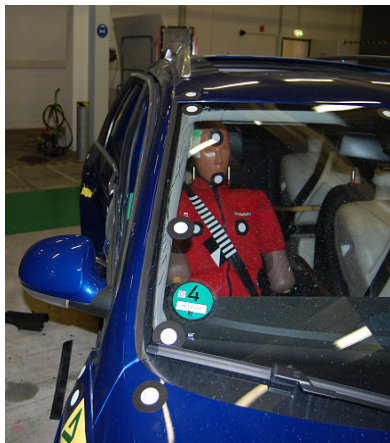
Figure 4. Head-on view

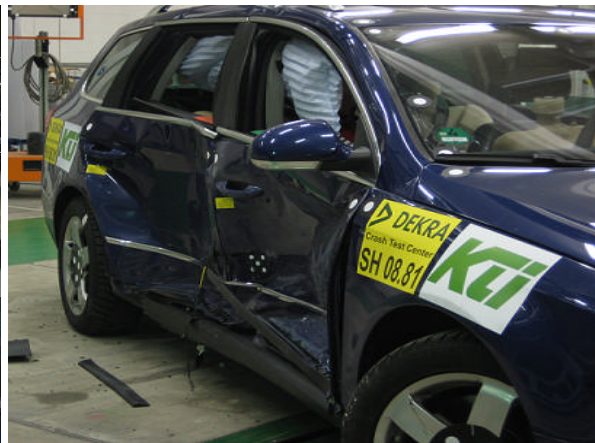
Figure 5. Damage to passenger side

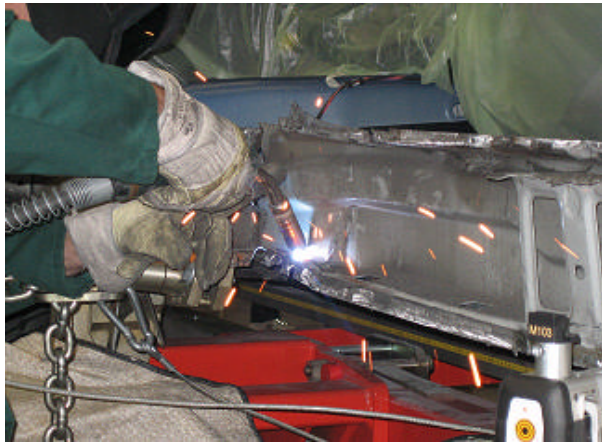
Figure 6. MAG-welding the inner sill

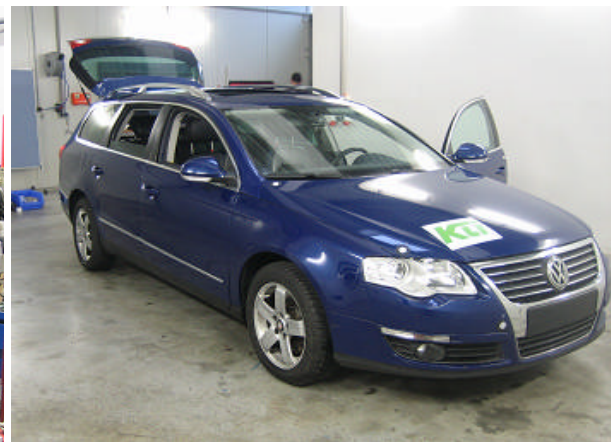
Figure 9. The completed repair

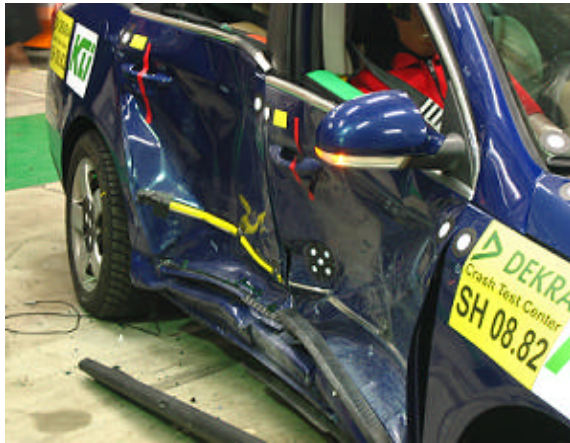
Figure 10. Damage after second crash

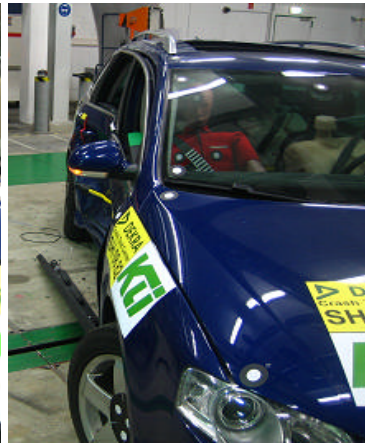
Figure 11. Higher intrusion to passenger compartment

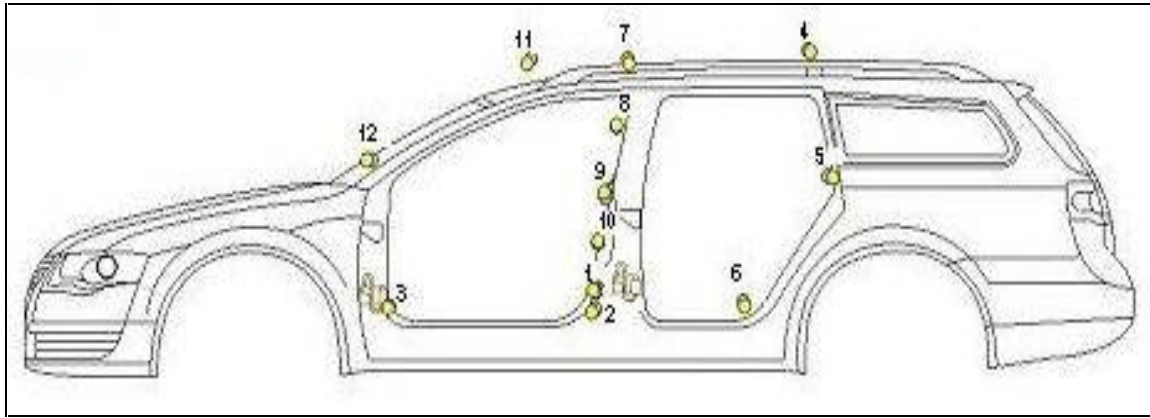
Figure 22. Measurement points

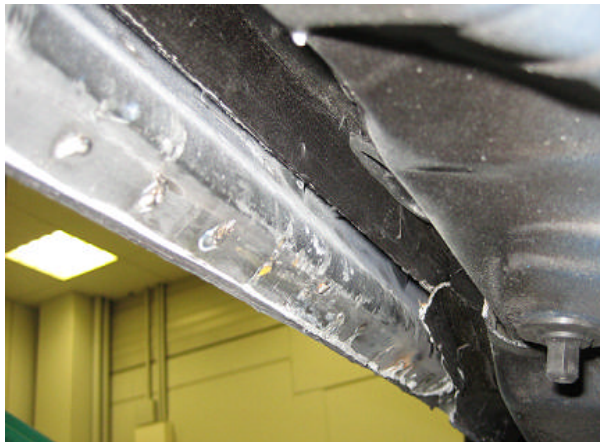
Figure 23. Disconnection of the sill after second crash

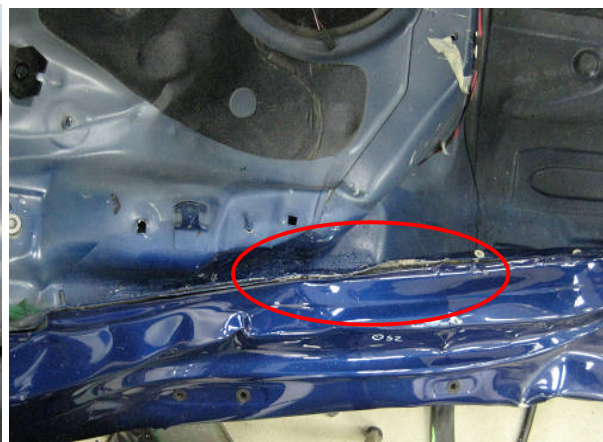
Figure 24. Disconnection of the inner sill after second crash

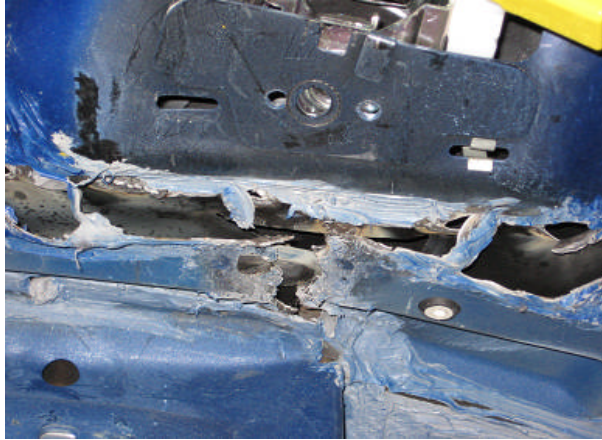
Figure 25. Disconnection between lower B-pillar and inner sill after first crash
